Cause, Effect and Moving Forward

**A comprehensive
inside view of
Lowdham flooding**
December 2020

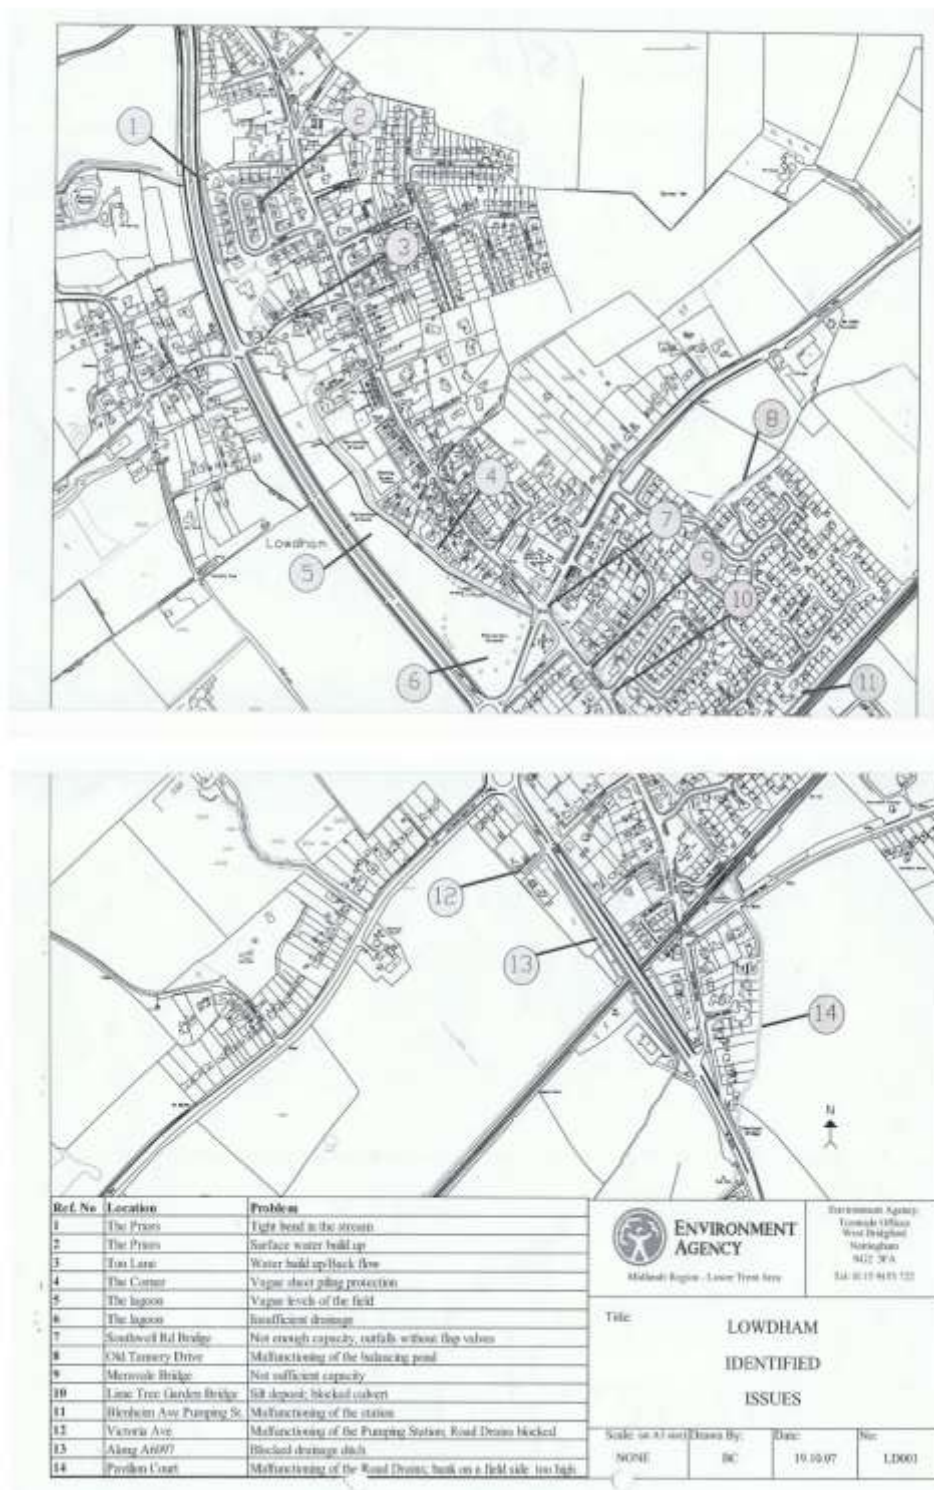
Figures 3 and 4 Environment Agency Identified Issues 2007

18. Reference numbers 4, 5, 7, 8, 9, and 10 remain outstanding issues. Reference 14 requires regular maintenance. Reference 2 and 12 are resolved, and References 13 and 14 should be resolved in December 2020. There are new issues which are highlighted in Section 3 of the report.

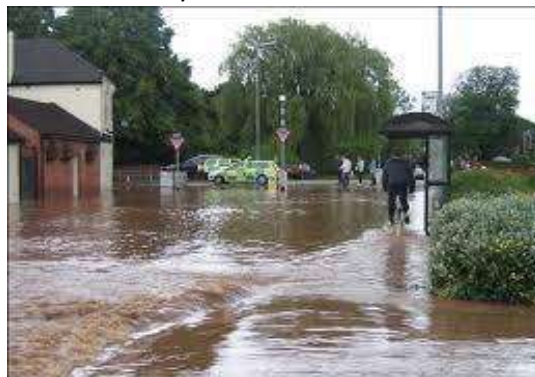
Figure 1 Lowdham 1:50,000 map

Figure 7 Main Street by WI Hut flooded from Cocker Beck

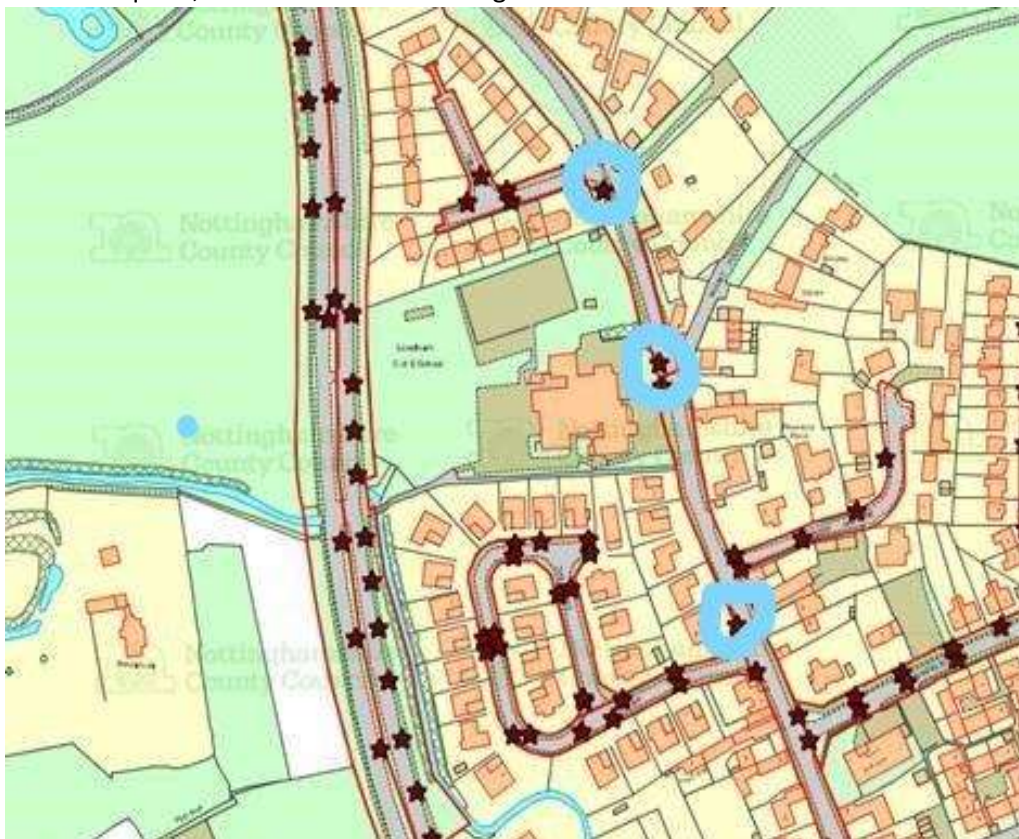
40. **Epperstone Road/Main Street/The Priors:** The number of gulleys on this section of road was inadequate, with two new ones being built in October 2020.

Figure 8 Location of 3 Gulleys on Epperstone Road/Main Street prior to October 2020

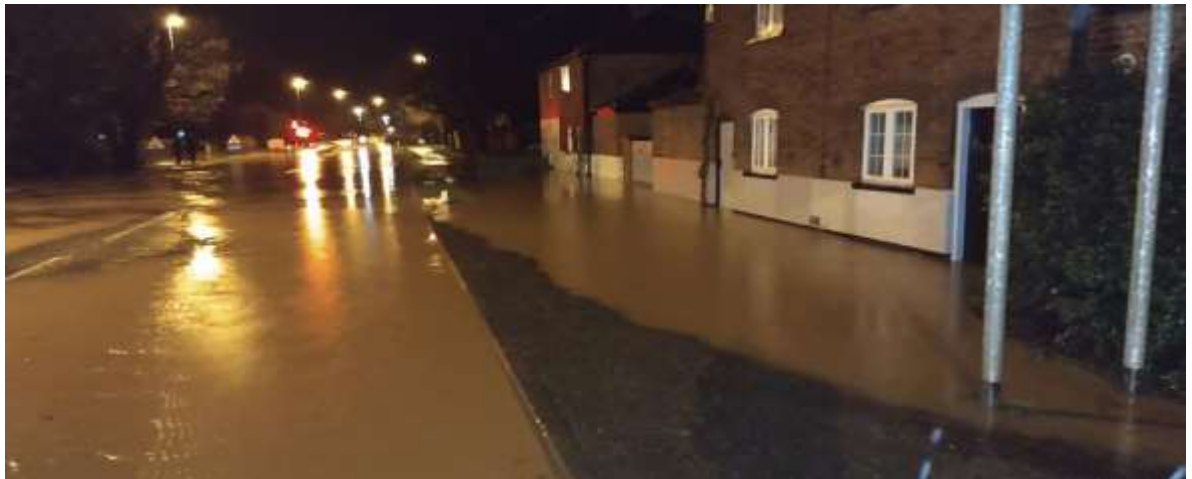
41. **Southwell Road:** Contractors found the culverts to be completely blocked in March 2020 after the February flooding. The gulleys had been cleaned in the month before the November 2019 flood and were reported as functioning. This means that the VIA maintenance system is in need of review because it must ensure that water passes between gulleys down clear culverts and not merely out of the chamber.

Figure 9 Southwell Road with blocked drains, road closure, and severe flooding to The Cottages

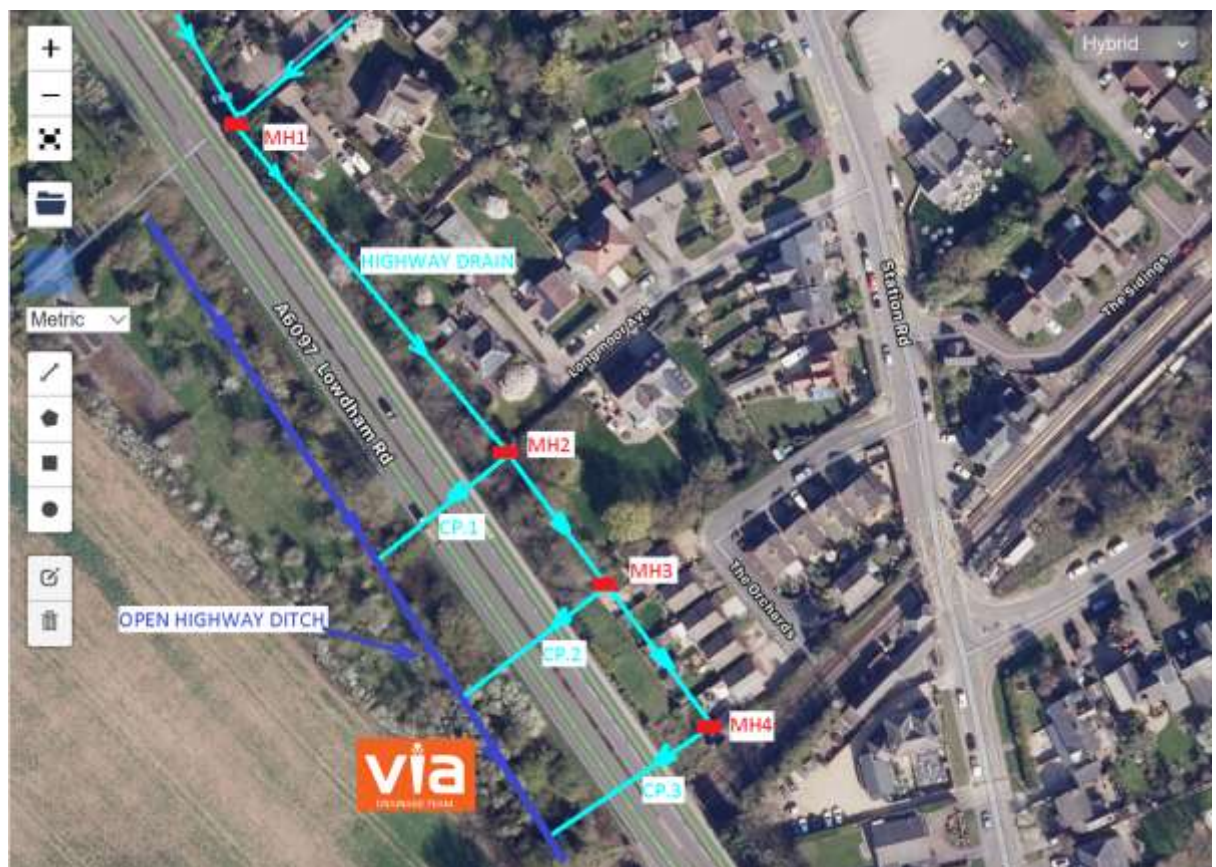
42. **Victoria Road/Station Road/The Orchards:** The culverts running parallel to, and under the A6097 (CP1 CP2 CP3) were found in September 2020 to be completely blocked and incapable of taking water underground. These key assets had not been inspected in a number of years to identify that they were inoperable. There is a VIA workplan to ensure they are clear by the end of November 2020.

Figure 10 Map of key culverts and ditches which were all inoperable in February 2020

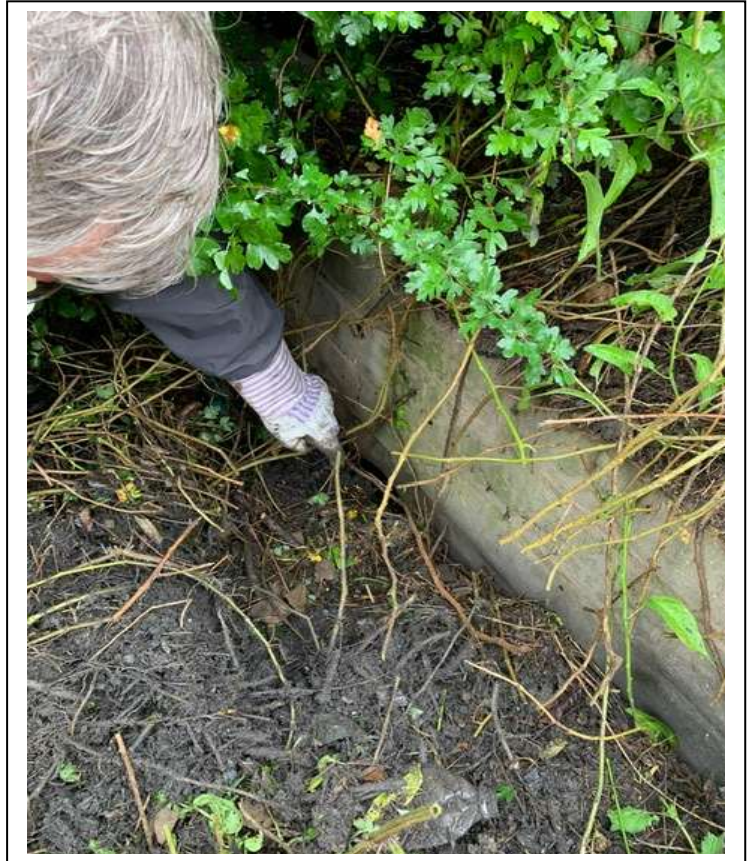
43. **A6097 ditches:** The ditches and culverts along both sides of the A6097 from Ton Lane to the roundabout are blocked and incapable of taking water.

Figure 11 Culvert on A6097 on east side completely buried preventing water passing under the roundabout. Fixed November 2020 thanks to VIA East Midlands

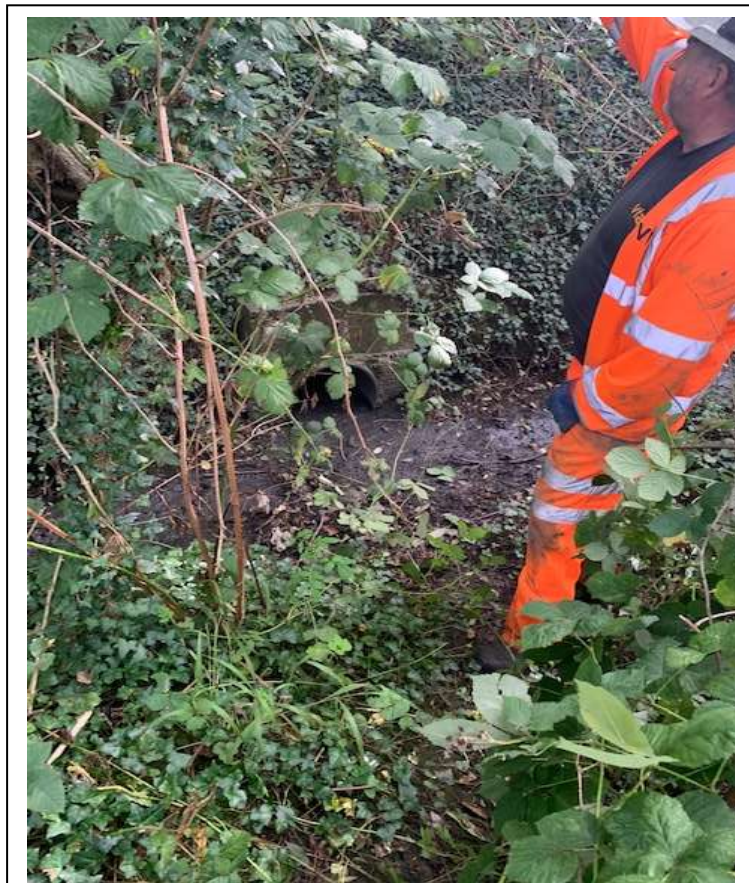
44. **West ditch A6097:** The ditch on the west of the A6097 from the roundabout to the railway bridge has not been maintained since 2008. It is full of silt and there is no fall from the culverts running under the A6097 which inhibits the flow of water under the railway (large clean culvert) and into the Bypass Feeder/Boundary Dyke towards the River Trent. There is a VIA workplan to ensure it is clear by mid December 2020.

Figure 12 Outfall of MH3 in Fig 9 in A6097 western ditch

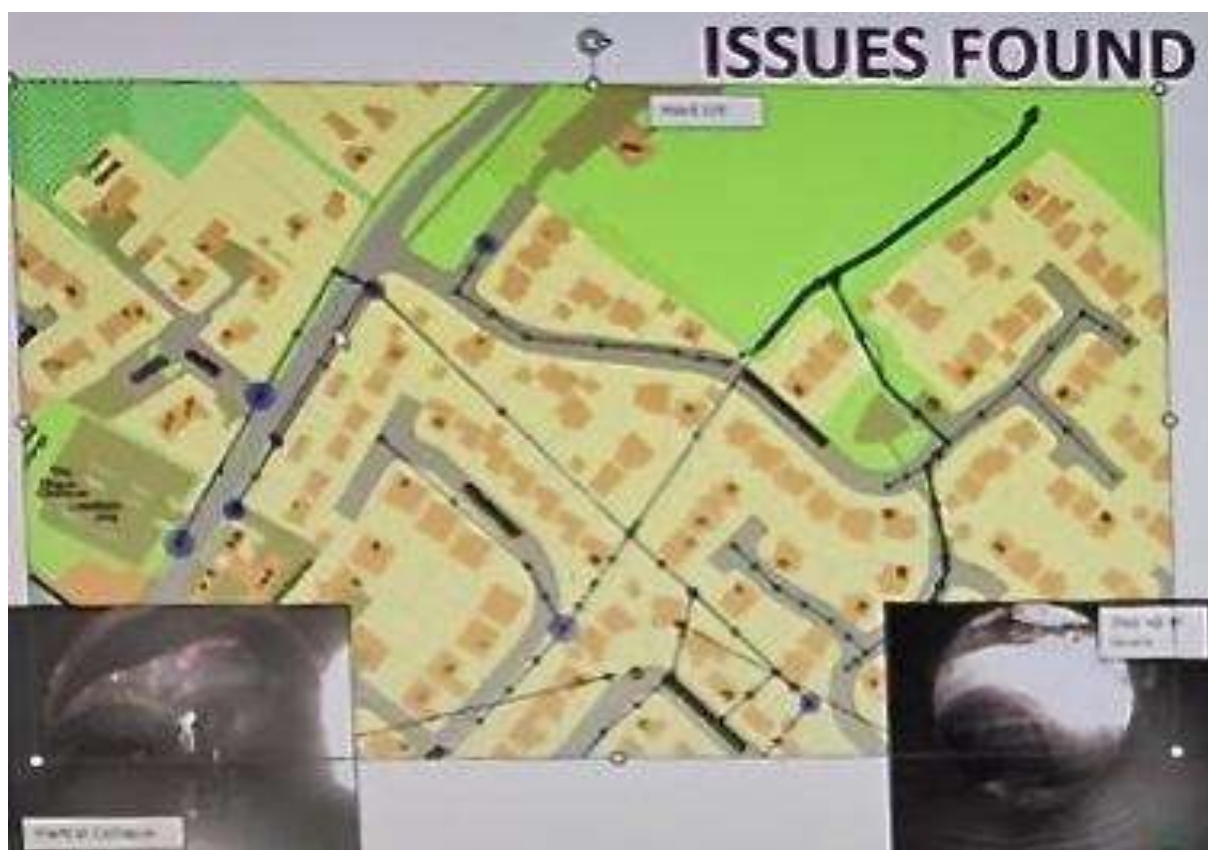
45. **Misaligned pipes:** The culverts that run into chambers in 19 Willow Holt and 8 Old Tannery Drive have misaligned pipes and are partially collapsed following camera work in March 2014. These lead directly to Tannery Dyke. This issue was identified 7 years ago. FLAG has reminded Nottinghamshire County Council (NCC) of this issue repeatedly since formation early in 2020. Action needs to be taken urgently to obtain access to these chambers because, with the culverts on Southwell Road cleared, more water will flow here.

Figure 13 Map and camera images of misaligned pipes and partial collapse area Willow Holt/Old Tannery Drive

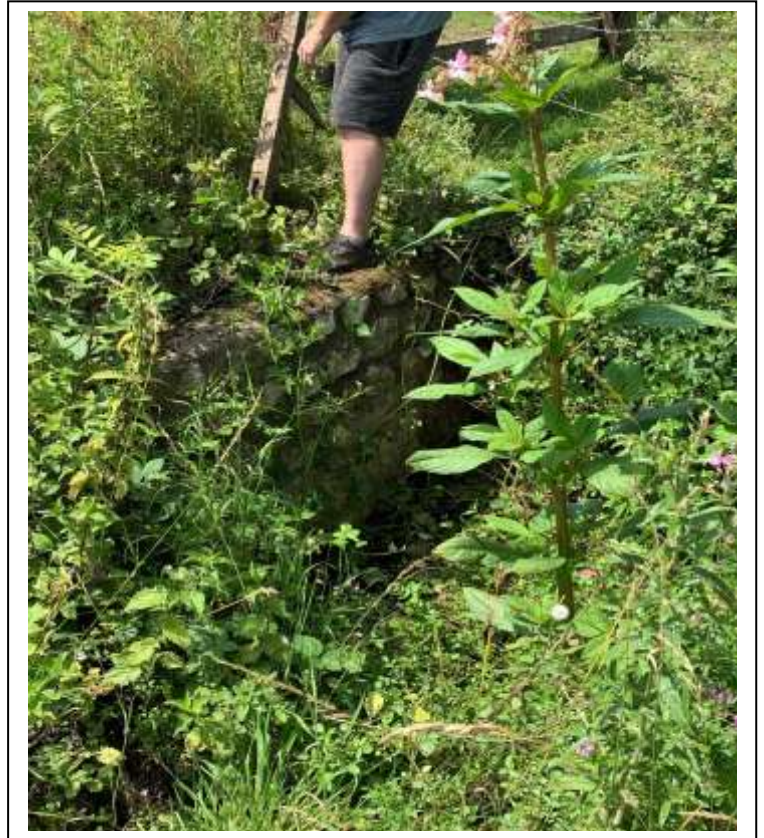
Figure 14 Double culvert far side Harrison's Garage too small and too high to be effective

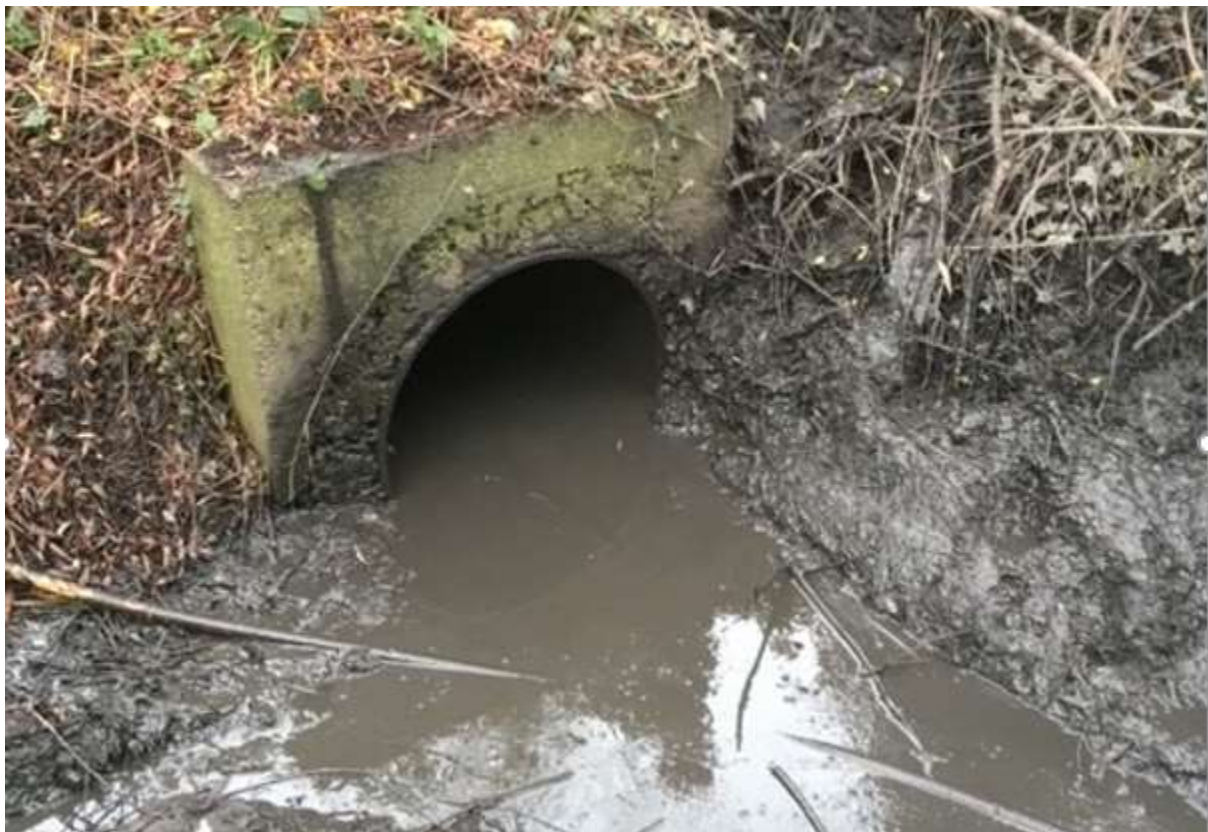
49. Bypass Feeder/Boundary Dyke. Bypass Feeder/Boundary Dyke takes water passing under the railway line west of the A6097. There is inadequate flow and it is going to be dug out and cleaned.

Figure 15 2Exit from Railway culvert into Bypass Feeder showing no flow after culvert cleaning by A6097

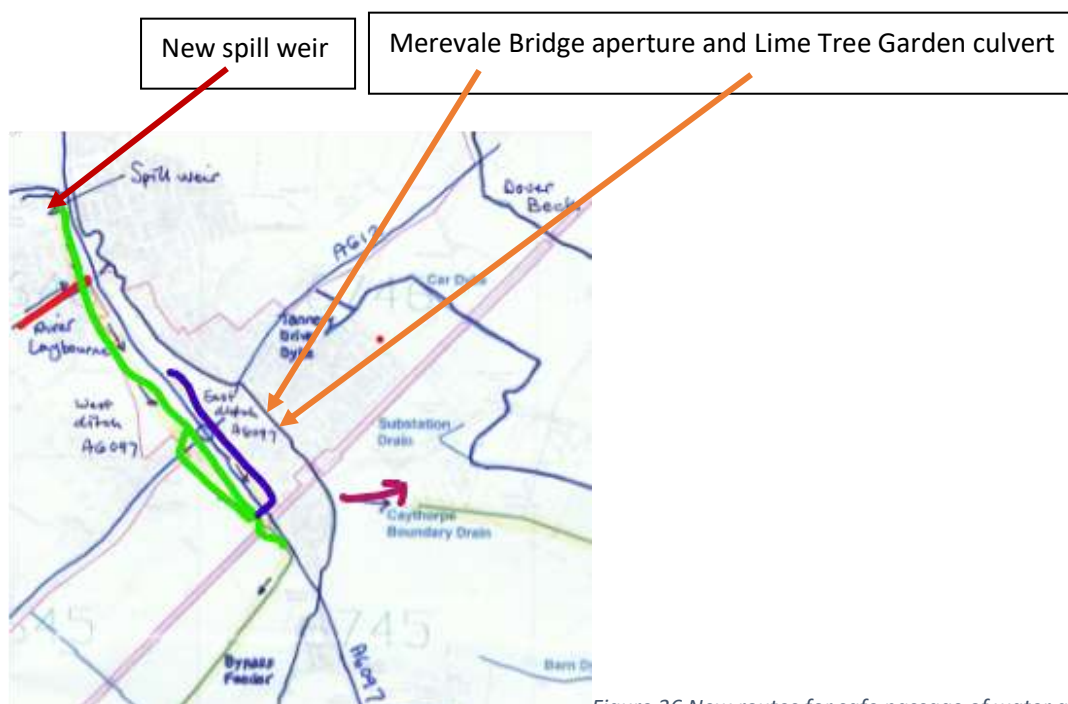
Figure 36 New routes for safe passage of water away

- a. The ditches alongside the A6097 north of the roundabout should be capable of taking water safely to the railway line culvert without ever entering the village and could be utilised to take water via a new spill weir as the Cocker Beck passes under the A6097 before it becomes a main river. NCC is asked to consider this option. See

- b. Divert River Laybourn into one of two A6097 ditches. See

- c. The cricket pitch lagoon could have a drain into the A6097 ditch would slow the rate of rise of the level in a flood situation. EA / NCC are asked to consider this option. See

- d. The Merevale bridge parapet could be adapted to allow water to pass more quickly through it. EA is asked to report on whether the flow of water through this aperture can be improved. See

- e. The culvert under Lime Tree Gardens bridge is blocked. EA is asked to have this unblocked to increase capacity. See

- f. The grips south of Caythorpe Road could be deepened to take effect sooner. EA is asked to model this. See
