Cause, Effect and Moving Forward

**A comprehensive
inside view of
Lowdham flooding**
December 2020

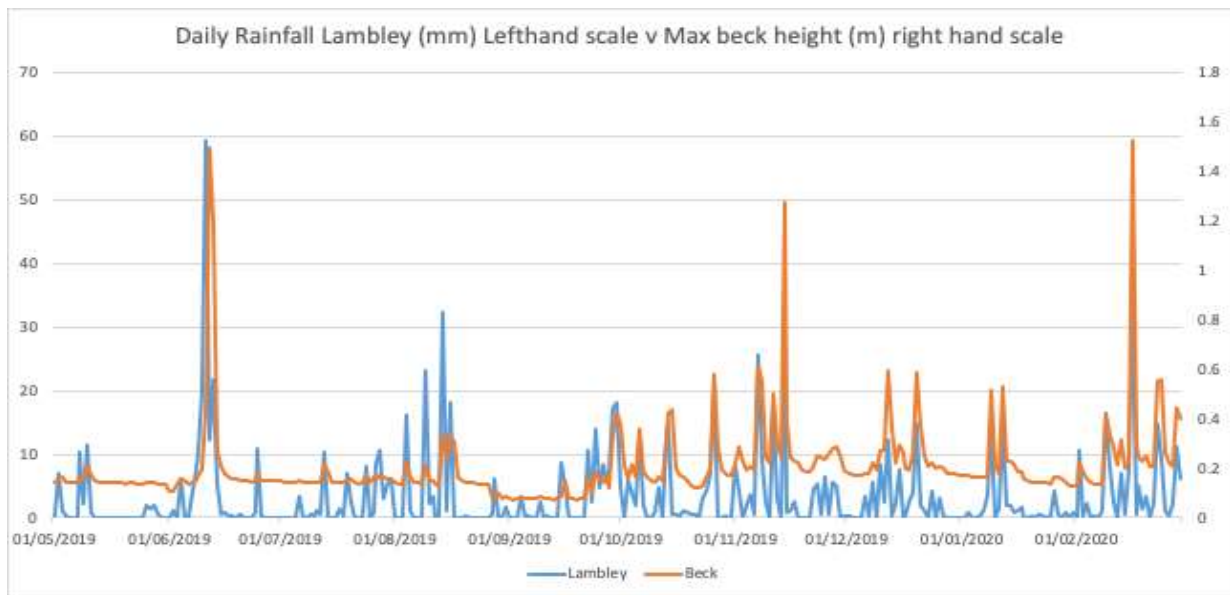
Figure 5 Graph showing relationship between Lambley rainfall gauge and Cocker Beck level gauge

32. Lowdham suffers from flash flooding so monthly rainfall figures do not tell the whole story. Daily rainfall levels at the Lambley gauge are similarly not in enough detail but by way of approximate correlation they are shown together with Lowdham Grange Beck levels in Figure 5.

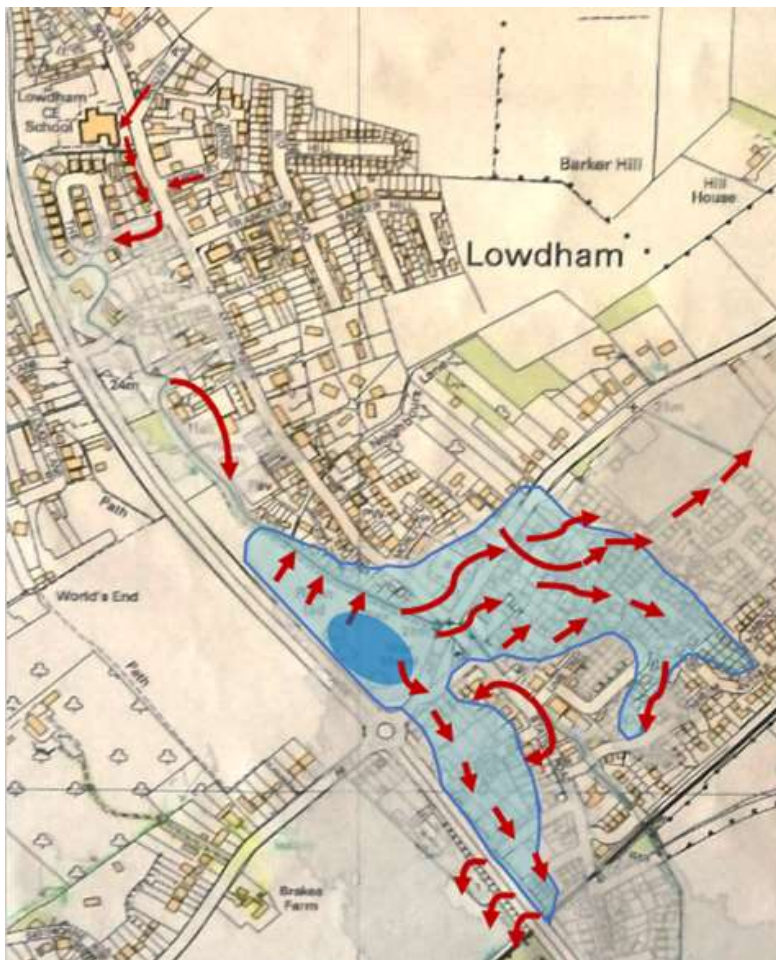
33. The diagram below shows the route that flood water takes. This information has been gleaned from surveys of those flooded and volunteers observing flood events. The EA has confirmed that these reports would support their modelling.

Figure 6 River flow routes. The blue symbol is the lagoon. We wish to be clear that not every house inside the blue area flooded internally but this is an illustrative map.
